**T-34 Spar Corp.**  
**2800 Airport Rd.**  
**Ada, OK 74820**  
**Phone 580-436-4833**  
**Fax 580-436-6622**

**T-34A/B Main Spar Carry-through Rotating Probe, Bolt-hole Eddy  
Current Inspection Procedure and Cold Work  
No. TSC 3507, Rev. C, dated 4/5/10**

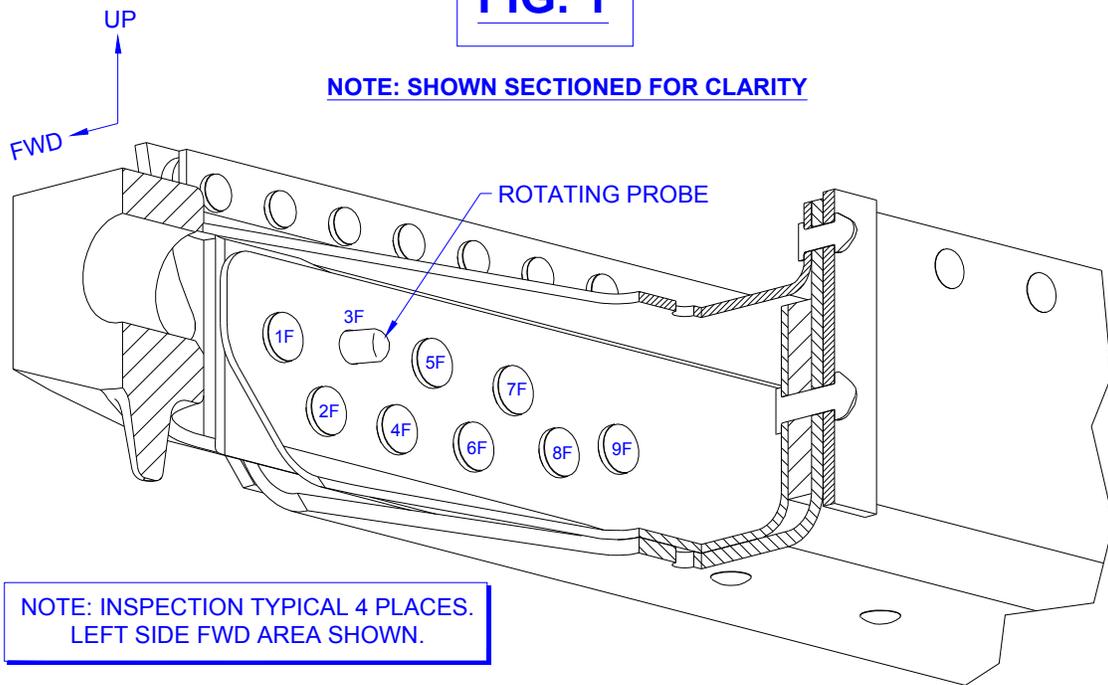
**FIG. 1**

**Description of Area to be Inspected:** (Ref: Fig. 1) The area to be inspected includes the two inboard-most holes (#8 and #9) four places (eight total) in the Left and Right Wing Attach Fittings of the Main Spar Carry Through Structure. Ref. Fig. No. 1. –Note rotating probe shown in hole #3, but only holes #8 and #9 need inspection at this time.

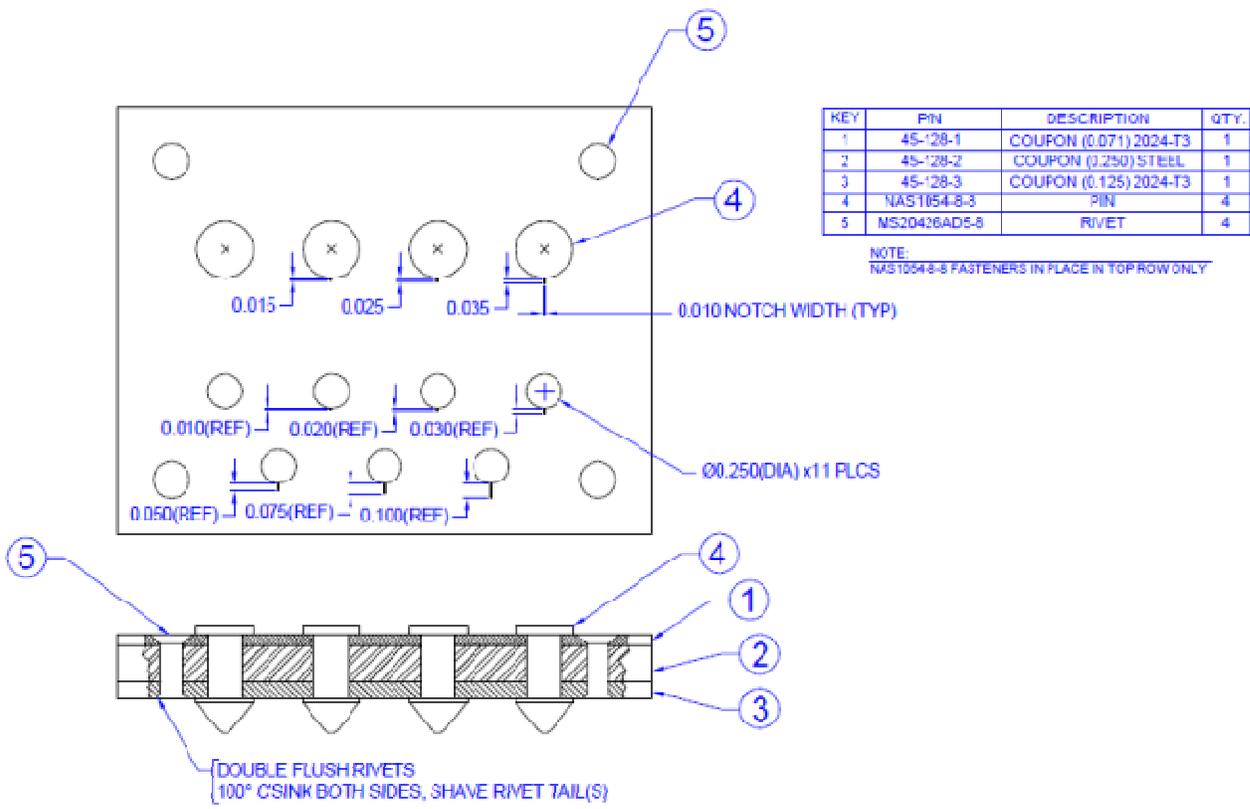
FIGURE 2: Detail of GAMI P/N 45-128

**Test Coupon Requirements:** The eddy current test coupon to be used is GAMI P/N 45-128 per Figure 2. Use .050” notch in through-hole for calibration.
