T-34 Spar Corp.

DOCUMENT NO.: 45-6460002

TITLE: INSTALLATION INSTRUCTIONS FOR T-34, T-34A, and T-34B MAIN WING SPAR LOWER WING BOLT REPLACEMENT AND TENSION CABLE PER T-34 SPAR CORP. AMOC TO AD 2004-25-51

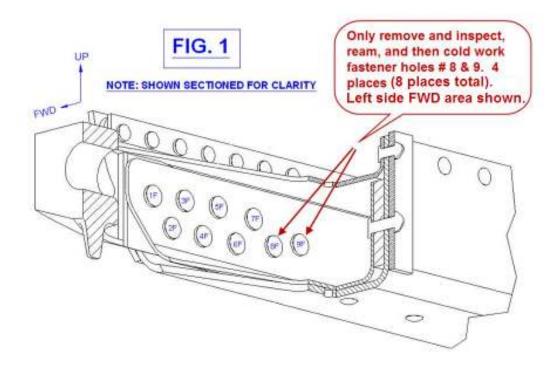
Fig 1. Location of 8 & 9 fastener holes in MSCTS for eddy current inspection, from TSC 3507, Rev C, 4/5/10.

- (3) Carefully identify and then split collars at fastener hole locations 8 & 9 (four places per side 8 total) as defined in Fig 1 of TSC 3507, REV C, dated 4/5/10. ONLY remove fasteners at hole locations 8 & 9. Then remove the collars from each of the #8 and #9 fasteners insuring not to damage MSCTS. Once collars are removed, gently tap fasteners out.

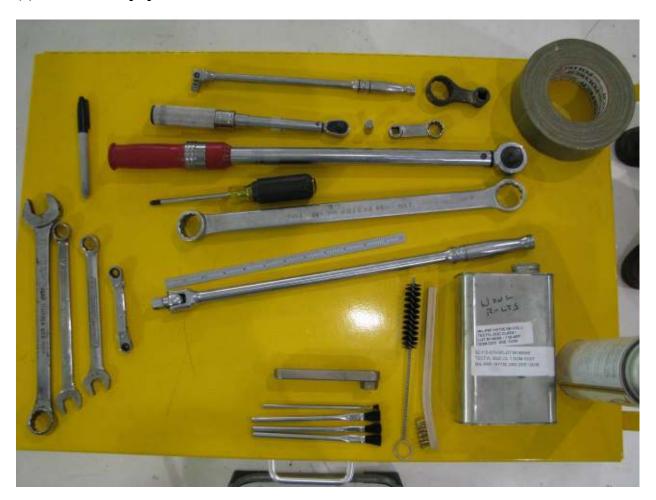
Fig. 2 Tools & supplies required for ALEC cable installation.

- i) A long reach 5/8ths inch, SIX POINT, box end wrench is required to install the special tension cable nut. A short reach wrench with a "cheater" will also work.
- ii) A torque wrench extension/adaptor sufficient to access the bath tub fitting tight clearance and allow the wing bolt nut to be torqued to 250 ft-lbs (3,000 in-lbs) from the bath tub fitting.
- iii) T-34 Wing Bolt tool kit to break loose and remove the existing bolts.

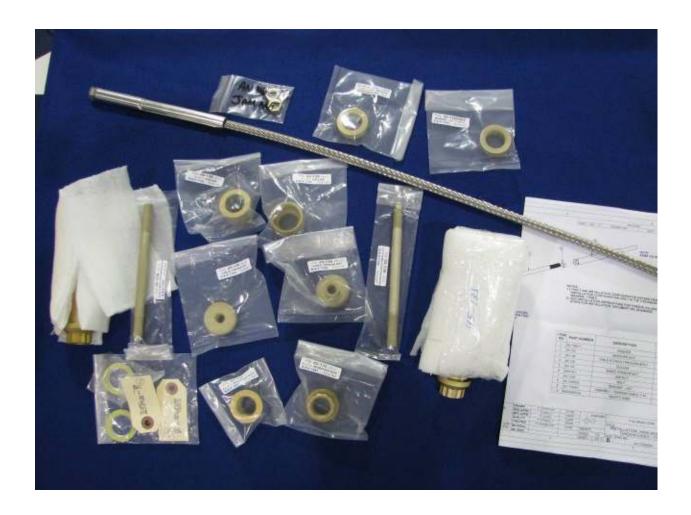
Fig. 3 ALEC parts to be installed on T-34 and T-34A aircraft. T-34 B is identical except the washers under the head of the wing bolts are 0.25" thick, rather than 0.43" thick for the A model.

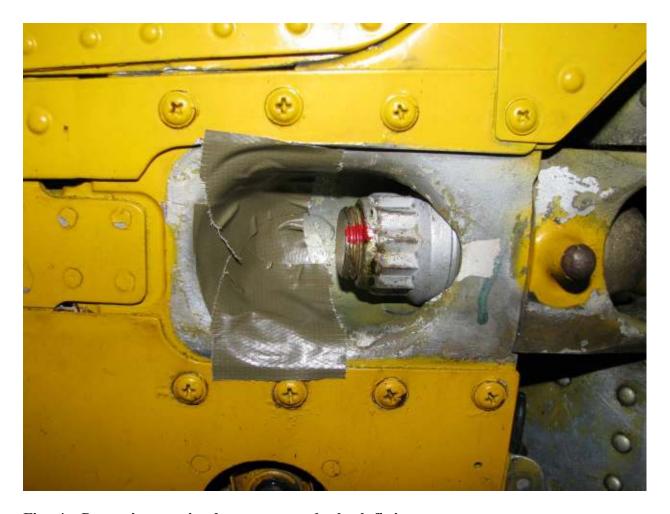
Fig. 4 Protective tape in place to protect bathtub fitting.

(1) Install at least one layer of protective tape or other suitable protection on interior surface of each bathtub fitting to insure that the bathtub fitting is not scratched or marred by wrenches or components during installation of ALEC cable. See Fig 4 for one example of appropriate protective measures.

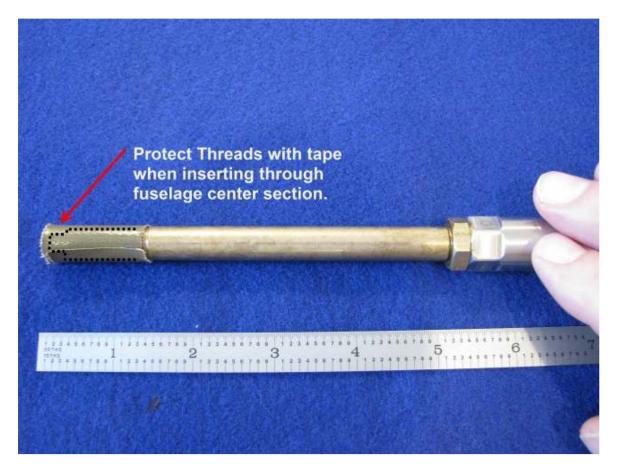
Fig. 5 Through Bolt in position with jam nut and fully inserted into cable swage fitting. Ready to be threaded through the T-34 center section.

- (10) Preassemble one Cable Attach Through Bolt (T-34 Spar Corp P/N 45-136) by applying Loctite® 262TM threadlock fluid to the second and third threads of the through bolt, inserting and screwing it fully into Tension Cable Assembly P/N 45-1750001. Position Jam Nut P/N AN316-7 in place on through bolt and adjust so it is loosely in place against the tension cable swage fitting. See Fig 5. Protect the exposed threads. The through bolt must be fully threaded into the swage fitting at this time. It will later be partially unscrewed. Continue installation as quickly as possible before threadlocker sets up. See Installation drawing 45-1750002, items 3, 6, & 9.

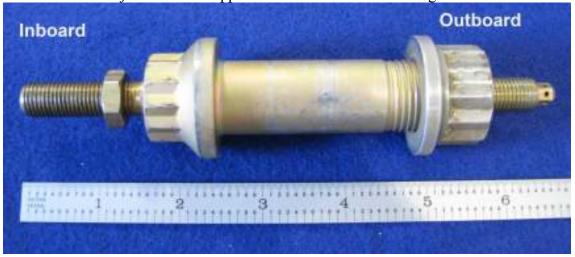
Fig. 6 Install one 45-136 Through Bolt and AN316-7 jam nut in position oriented as shown. This is done by inserting the Through Bolt into the lower access with the inboard side first and then manipulating the outboard end of the Through Bolt through the head of the newly installed Wing Bolt and then moving the Through Bolt outboard so that the end protrudes into the bathtub fitting area. After this is in place, and from the same side, insert cable/Through-Bolt assembly (see Fig 6a to 6f) from the same side with the Through-Bolt first. Through-Bolt is then routed through the entire center section. Then remove thread protection and manipulate the tip of the Through Bolt to pass it out through the open hole in the Wing Bolt on the opposite side.

(11) Pre-install a 45-136 through-bolt into one side of the T-34. It should be positioned with the AN316-7 jam nut in the approximate location shown in Fig. 6.

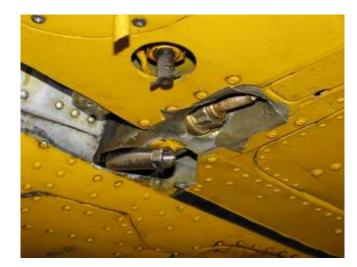
Fig 6c Fig 6d

Carefully install preassembly from step 10, above, into open area on lower side of MSCTS attach fitting, and feed the cable assembly (Through-Bolt first) to other side. See Fig 6a to 6g. Remove thread protection from the end of the Through Bolt. Then manipulate the through bolt and pass it fully through hole in the installed and previously torqued wing bolt. When inserted fully, the jam nut should be resting against the inboard head of the main wing bolt as shown in **Fig.6 f.** See the sequence of pictures in Fig. 6a to 6g.

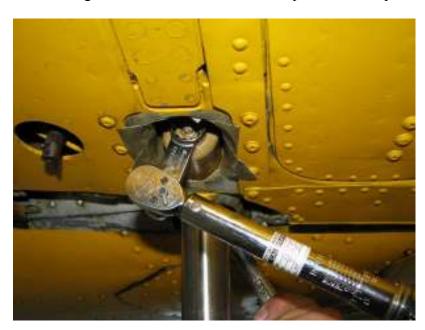
Fig 8. Pre-tension of 50 in-lbs applied.

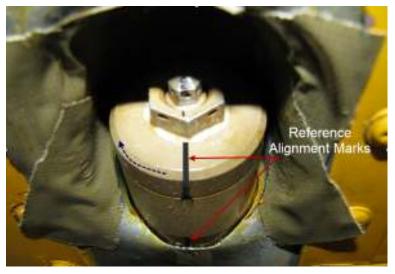
Fig. 9. After pre-tension of 50 in-lbs is applied, establish reference marks, and then further rotate tension nut 4½ to 4¾ turns. Use 5/8ths 6 point box end long reach wrench. A short reach wrench can be used, but it will require a "cheater." Note: before beginning 4½ to 4¾ turn, the through bolt threads are still recessed inside the cable tension nut.

(21) After achieving satisfactory positioning of threads into the tension nut on the active end to be torqued, mark rotational position of Cable Tension Nut with a radial mark and a corresponding and aligned mark on the base of the associated nut which secures the main wing bolt and a small mark on the square ½ inch tip of the through bolt. See Fig. 9.

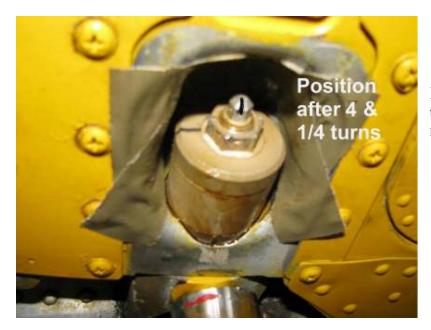
Fig. 10 Tension Nut after 4 ¼ turns (continue rotating tension nut an additional ¼ turn).

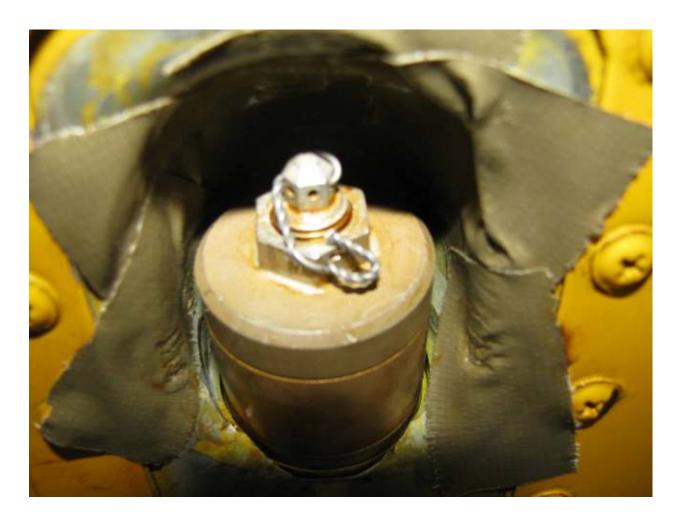
Fig. 11. Properly installed and torqued ALEC cable. Each side is symmetrical at the bath tub fitting and internally with respect to the thread engagement into the swage fitting. The tension nut, above, has been rotated $4\frac{1}{2}$ turns after a pre-torque of 50 in-lbs has been applied to the tension nut.

- (14) The objective is to finish the installation process with approximately two threads of the through bolt extending into the bath tub fitting. This requires some adjustment and balancing of the location of the through bolts and their respective engagements into the swage fittings on each side. Each side should end up with approximately the same number of threads showing between the swage fitting jam nut and the head of the Wing Bolt. And, each side should end up with approximately 2 threads showing on the tension nuts after all pre-torque and final tension has been applied. Fig. 11 below depicts the final configuration after safety wire has been installed.
